Manhole Inspection Summary

Manhole # S29G__055MH

Insp Date: **4/1/09 12:23 PM**

Location Address: **821 HOLLINS ST**

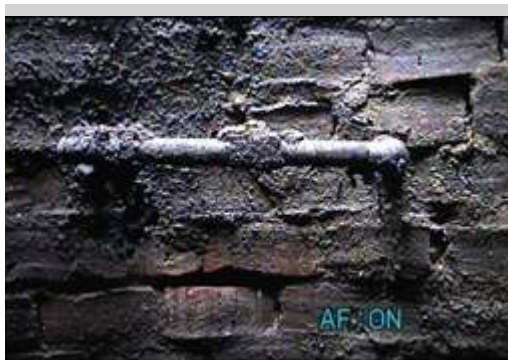
Defect 6

Condition: ☐ Sound ☐ Cracked ☐ Root Intrusion ☐ Loose Brick ☒ **Deteriorated**

Infiltration: ☐ None ☐ Joint ☐ Cracks ☐ Mortar ☐ Roots ☒ **Wall**

Surcharge ☒ **Evidence Of Surcharge** Depth: **6** (ft.) ☐ Active Surcharge Present

deteriorated corbel; signs of surcharge;
infiltration at corbel wall

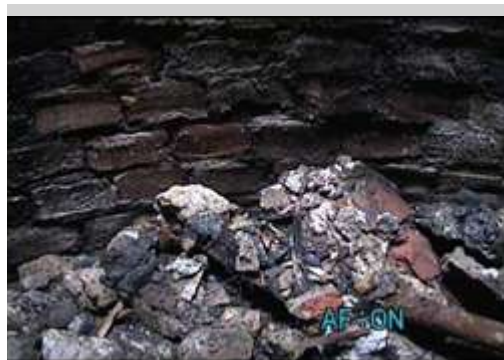
Defect 4

Condition: ☐ Sound ☐ Cracked ☐ Root Intrusion ☐ Deteriorated ☐ Leaks ☒ **Debris**

DEBRIS ON BENCH

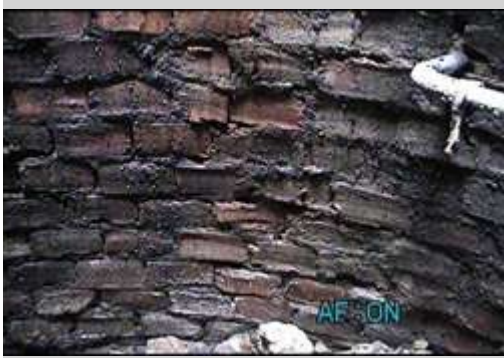
Defect 5

Condition: ☐ Sound ☐ Cracked ☐ Root Intrusion ☐ Loose Brick ☒ **Deteriorated**

DETERIORATED BARREL

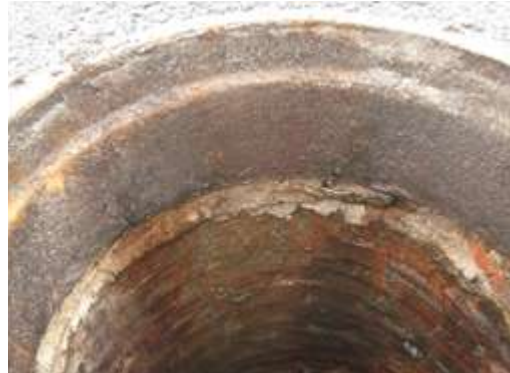
Defect 2

Frame Offset: **2** (in.) Condition: ☐ Sound ☐ Cracked ☒ **Leaks**

INFILTRATION LID/COVER

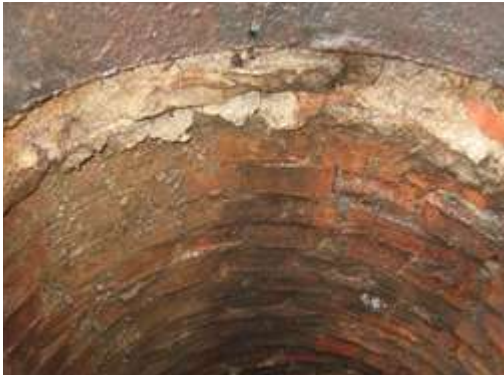
Defect 1

Condition: ☐ Sound ☐ Cracked ☐ Root Intrusion ☐ Loose Brick ☒ **Deteriorated**

Infiltration: ☐ None ☒ **Joint** ☐ Cracks ☐ Mortar ☐ Roots ☐ Wall

frame offset 2in; chimney deteriorated & joint infiltration

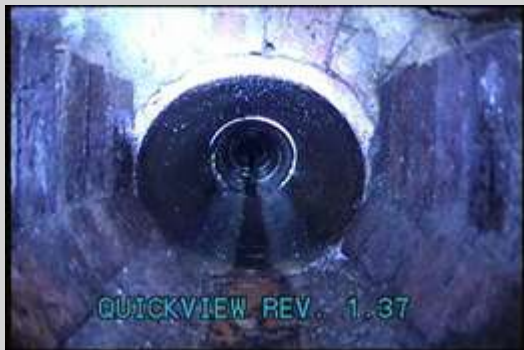
12 O'Clock Outflow

Pipe Height: **8.4** (in.) Rod and Bar (Angled)
Pipe Material: **Clay** ☐ Pipe Lined
Invert Depth: **9.40** (ft.) Flow Characteristics: **Slow**
Deposits: ☒ None ☐ Mud ☐ Sludge ☐ Debris ☐ Grease
Silt Depth: **0** (in.) Deposits Extent:
Infiltration: **None** Pipe Seal Cond: **Sound**

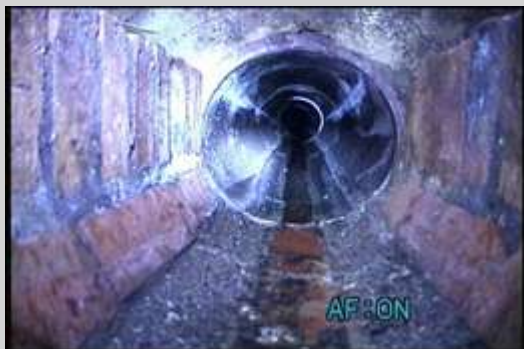
6 O'Clock Inflow

Pipe Height: **8.4** (in.) Rod and Bar (Angled)
Pipe Material: **Clay** ☐ Pipe Lined
Invert Depth: **9.44** (ft.) Flow Characteristics: **Slow**
Deposits: ☒ None ☐ Mud ☐ Sludge ☐ Debris ☐ Grease
Silt Depth: **0** (in.) Deposits Extent:
Infiltration: **None** Pipe Seal Cond: **Sound**
